All Issue Details

Project: SPX19432

Order#: 1306986-iRW **Part#:** TRELLIS

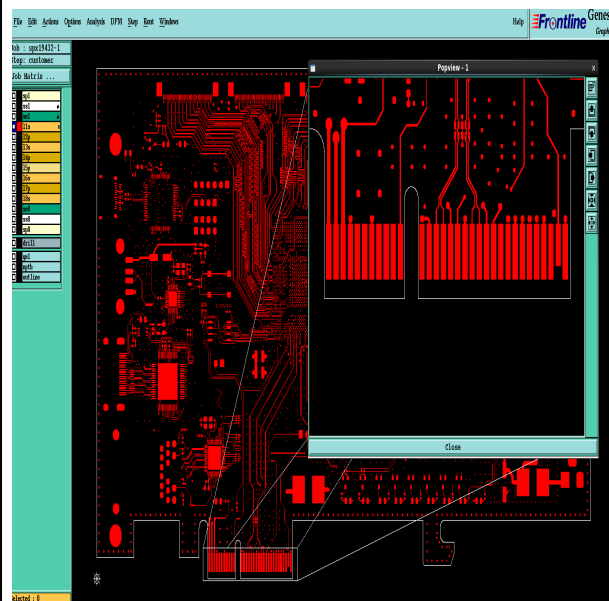
Screenshot.png

While performing DFM validation, we observed finger like features are present but web Spec calls for gold finger as "None". Please confirm whether you require hard gold plating for the fingers or you want the whole board to be ENIG finish. FYI: In case of hard gold plating requirement for the fingers, we need to revise the quote for which our sales team will be in touch with you.

No gold plating is required. Whole board ENIG.

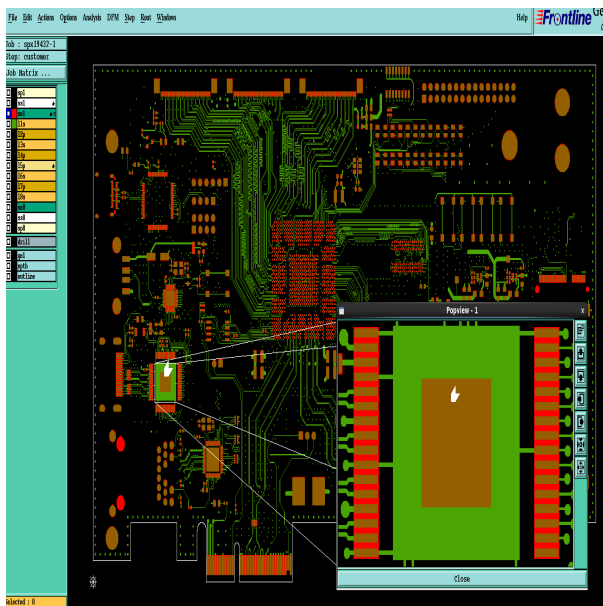
top maks.png

While DFM validation, we observed partial mask opening for rectangular pad at one location in top mask layer. Find Enclosed snap shot for your quick reference. Can we provide complete mask opening at this location(Pad size+4Mils) OR would you like us to proceed as is? Please confirm.

Provide complete mask opening at this location(Pad size+4Mils).

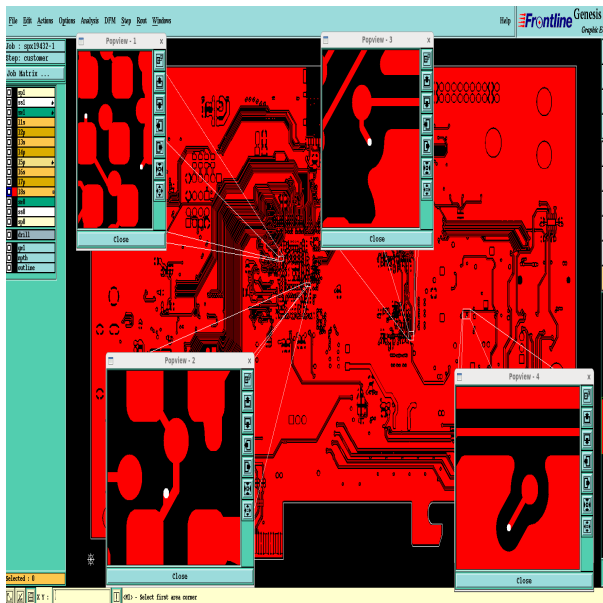
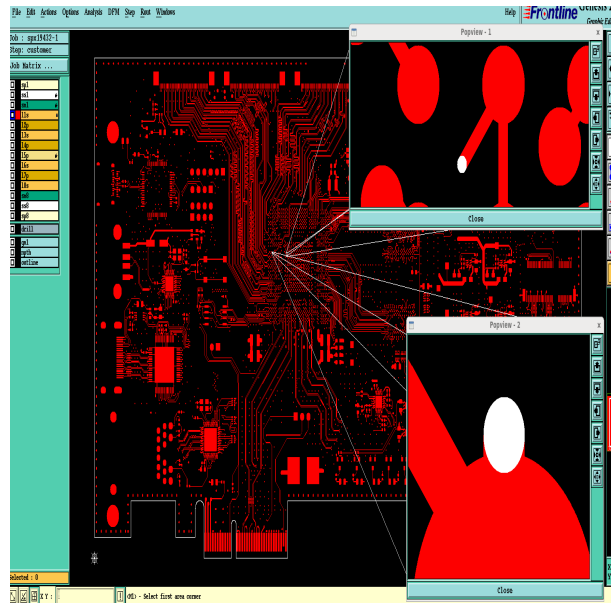
While performing DFM validation on your order, we observed few un-terminated traces (stubs) in top and bottom layer. Please confirm whether this is by design or else advise. Attached snap shot for your quick reference.

I was just looking into this. Please proceed as is.

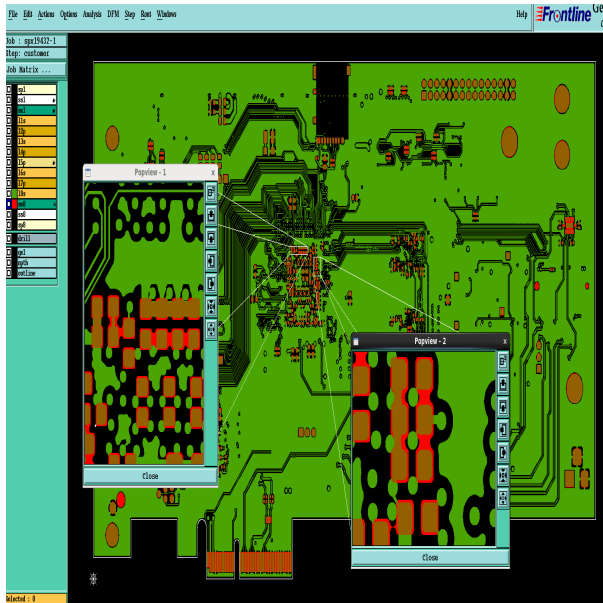
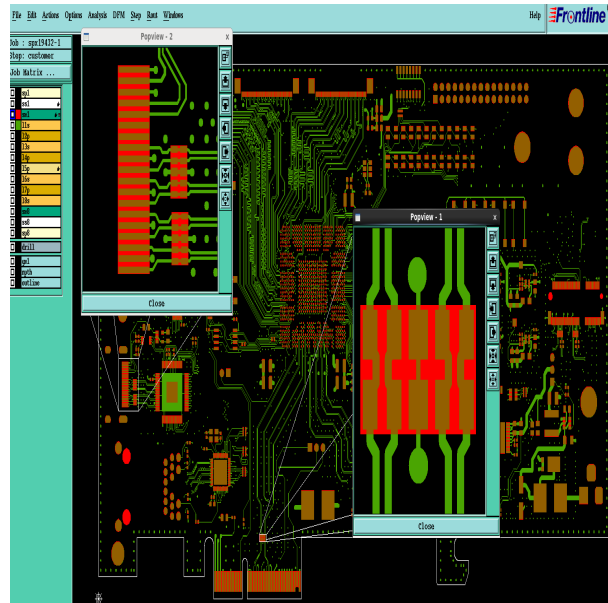
While performing DFM validation we observed that, Gang mask opening is provided in both solder mask layer. Find attached snap shot for your quick reference. This job is going to be assembled at our facility and we prefer individual mask opening. Please allow us to remove Gang relief and go ahead with individual mask opening. Please confirm.

Ok, confirmed.

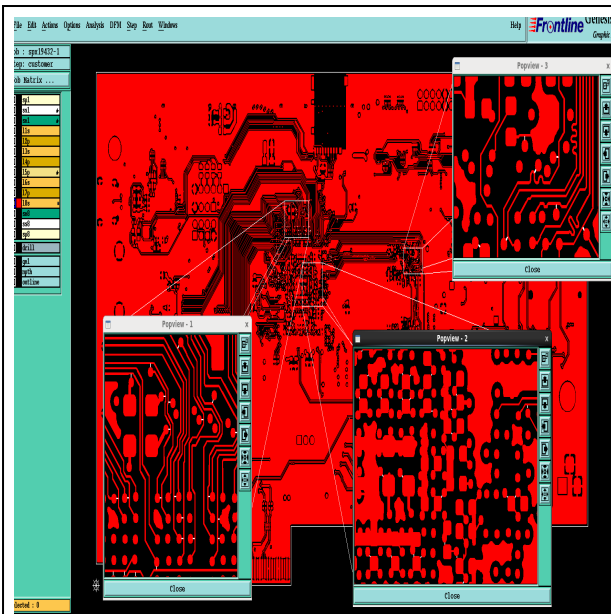
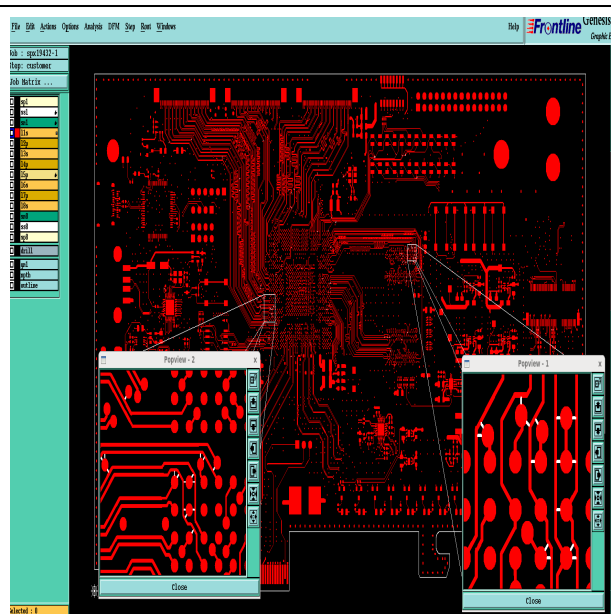
While performing DFM validation on your order we observed that 3.042 mil spacing on your design (top and bottom layer) but web spec calls 4 mil spacing. Also less than 4Mils spacing is not qualified for Web orders. This may required custom quote for which our sales team will get in touch with you.

Ok, please proceed with custom quote.

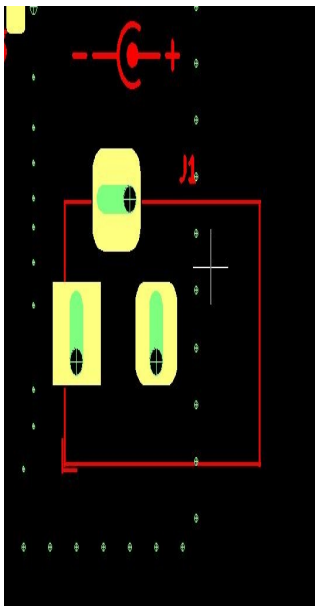
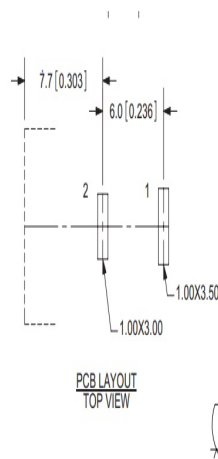
j1.JPG

DFA checks of your files show a footprint mismatch of components J1 (Line Item# 29) [MPN: PJ-037A] in GERBER files w.r.t. mechanical dimensions as per datasheet. As shown in image, Gerber footprint is not matching with recommended land pattern. Kindly provide an alternate part# for this or advise if we need to make component DNI.

We will place it on available footprint.

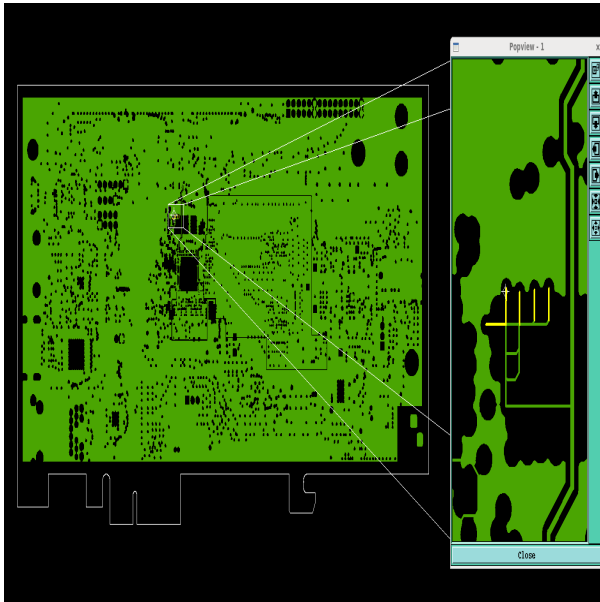
160832-stubs on layer4.png

While performing DRC on your order, we observed stubs(Un-terminated traces) on inner layer4 at 5 locations. Please confirm can we proceed as is or else advise. Screen shot attached for your reference

Proceed.

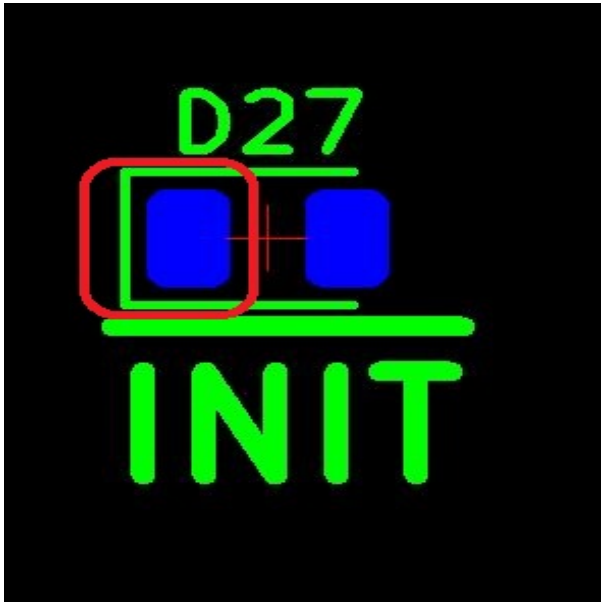
D27.jpg

We need you to advise if the marked pad of components mentioned below is cathode: D27 (Line Item# 22) [MPN: LH R974-LP-1] D8,D2,D26,D4,D5,D6,D7,D9,D10,D11,D12,D13 (Line Item# 24) [MPN: LG R971-KN-1]

D27 Cathode is on the left, as circled.

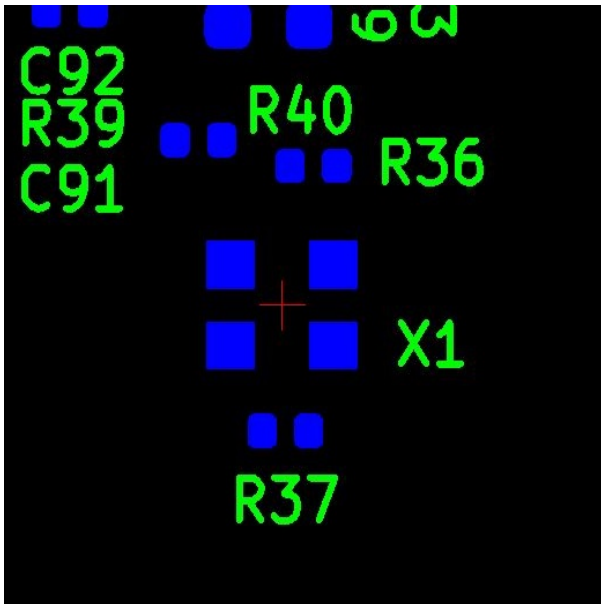
X1.jpg

We need you to advise for the PIN1 marking for below mentioned components as it is missing in silkscreen layer. X1 (Line Item# 95) [MPN: ASE-12.000MHZ-LC-T]

X1 Pin 1 is bottom left in your image.

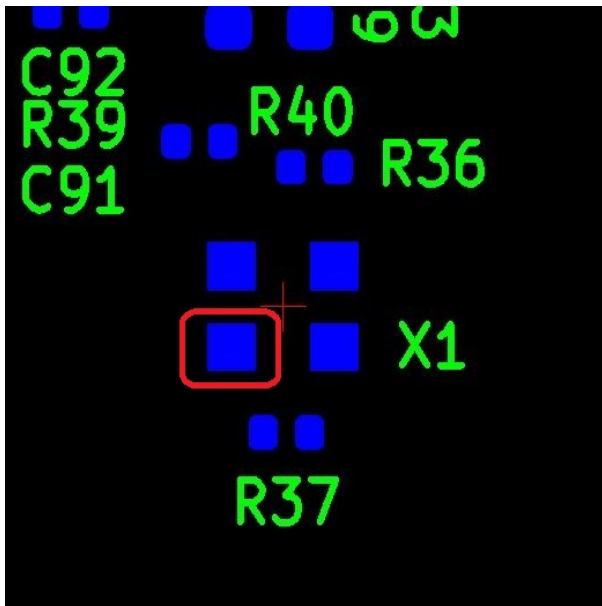
X1.jpg

As per your reply we have considered below marked pad as pin1.

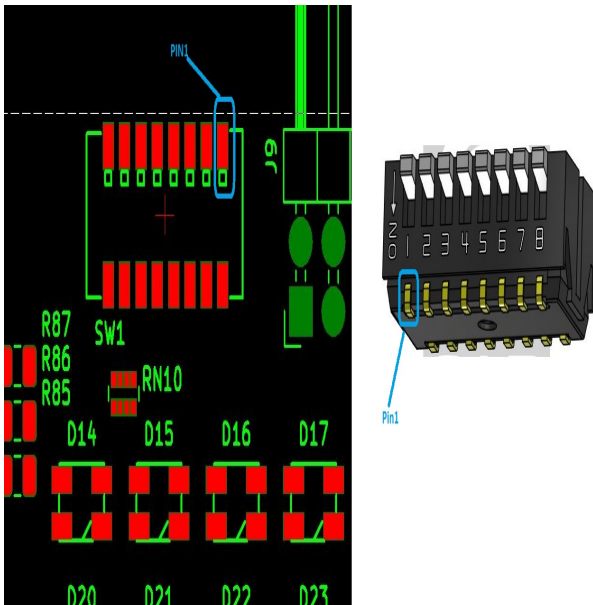
Capture.JPG

For the DFA checks, we need you to advise if the marked pad of components mentioned below is pin-1: SW1 (Line Item# 73) [MPN: CHP-081TA]

See attached photo of board. It looks like you have pin one in opposite corner in your diagram.
